MATERIALS FOR POTASSIUM LUBRICATED JOURNAL BEARINGS

Quarterly Progress Report No. 9
Quarter Ending July 22, 1965

prepared for
NATIONAL AERONAUTICS AND SPACE ADMINISTRATION
CONTRACT NAS 3-2534

SPACE POWER AND PROPULSION SECTION
MISSILE AND SPACE DIVISION
GENERAL   ELECTRIC
CINCINNATI, OHIO 45215

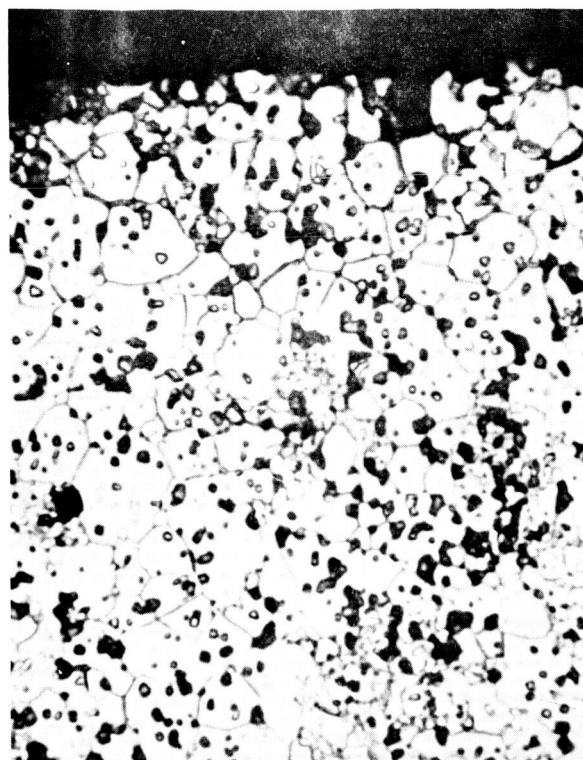
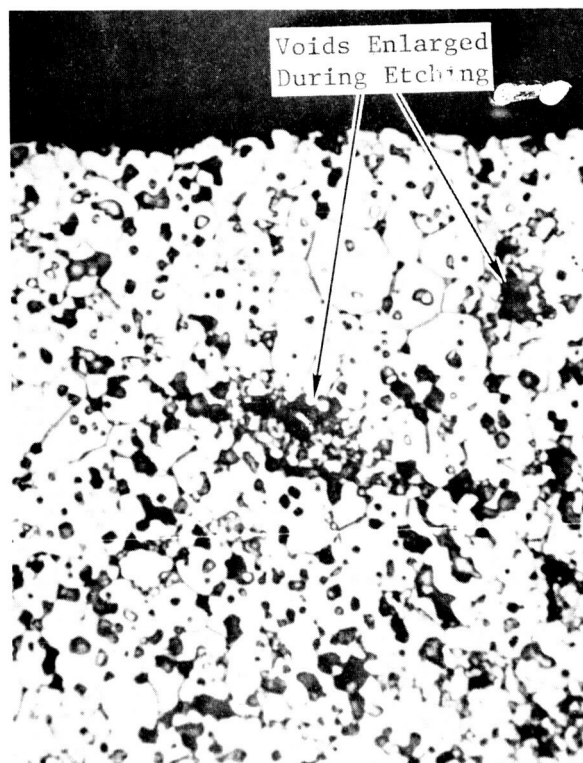
Figure 30. Microstructure of TiC+5%W Before and After Exposure to Potassium Liquid for 1000 Hours at 1600°F.
Etchant: 80% HNO_3 +20%HF

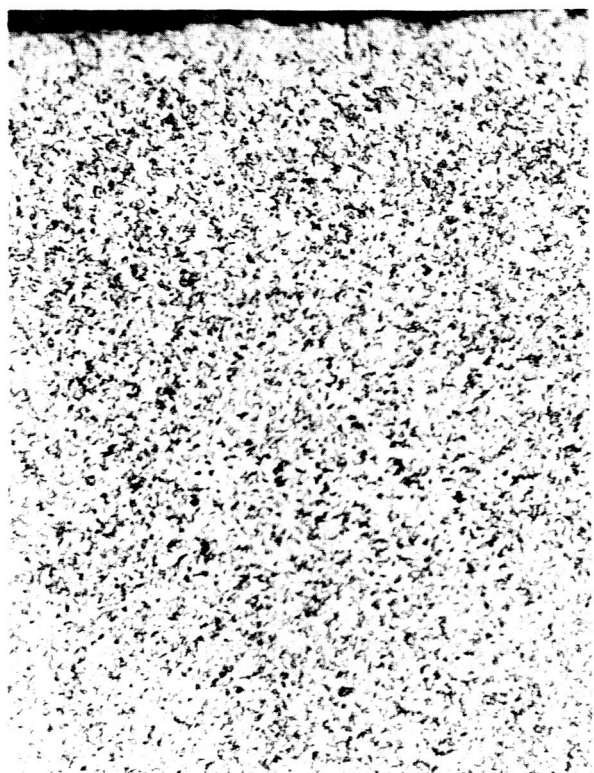
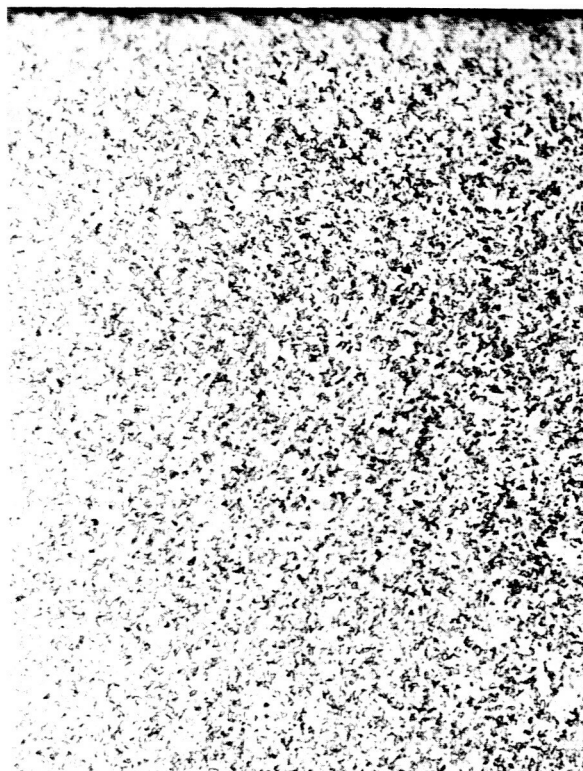
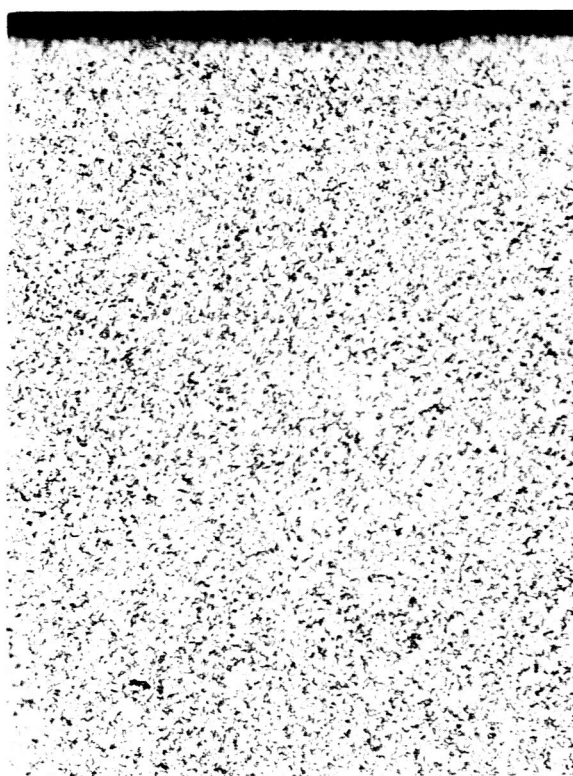
Figure 31. Microstructure of Grade 7178 (85.6%W-6.9%Mo-1.8%Cb-0.3%Ti-5.7%C) Before and After Exposure to Potassium Liquid and Vapor for 1000 Hours at 1600°F.
Etchant: 10%NaOH, Electrolytic

Metallographic examination of all specimens exposed individually to potassium for 1000 hours at 1600°F has been completed. No significant changes in microstructure were observed in any of the following materials as a result of the exposure to potassium liquid or vapor: Mo-TZM alloy, unalloyed tungsten, TiC+10%Mo, TiC+10%Cb, Lucalox (Al_2O_3) and TiB_2 ; slight surface attack to depths of 0.0002 to 0.0007 inch were observed in specimens of Carboloy 907, Carboloy 999, TiC and TiC+5%W; some surface roughening was apparent with the K601 specimens exposed to potassium liquid; and a general chemical reaction between Zircoa 1027 and potassium was observed changing the color of the specimens from light yellow to dark grey throughout the entire cross section. Although no corrosion reactions were evident for the Grade 7178 and Star J materials, morphological changes due to the thermal exposure were observed. Solution/aging reactions occurred in the Star J material and possible coalescence of the eutectic phase was observed in Grade 7178.

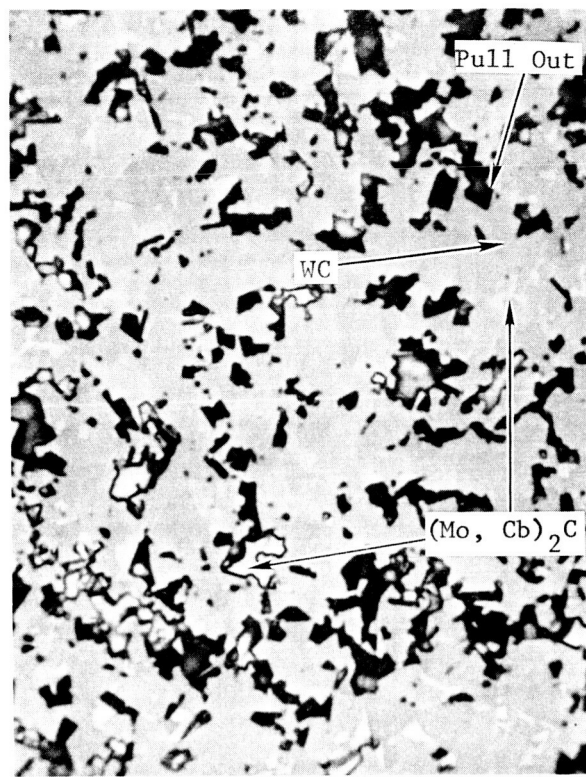
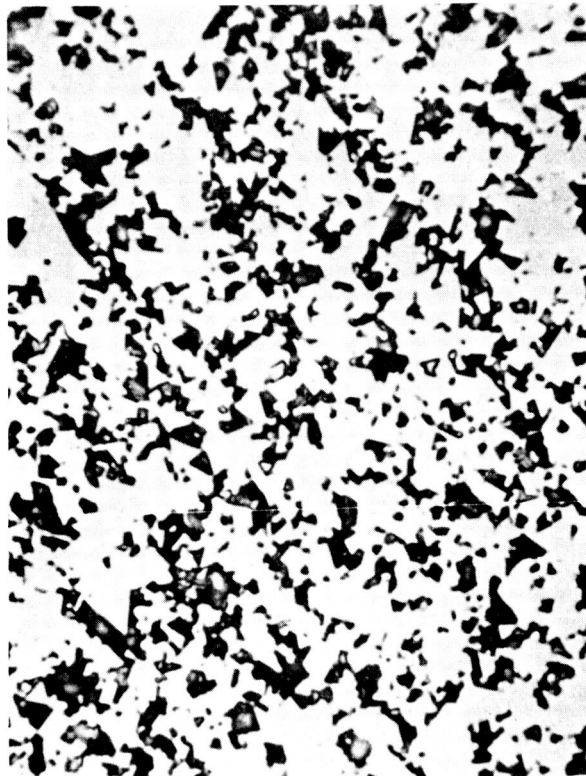
Figure 32. Microstructure of Grade 7178 (85.6%W-6.9%Mo-1.8%Cb-0.3%Ti-5.7%C) Before and After Exposure to Potassium Liquid for 1000 Hours at 1600°F.

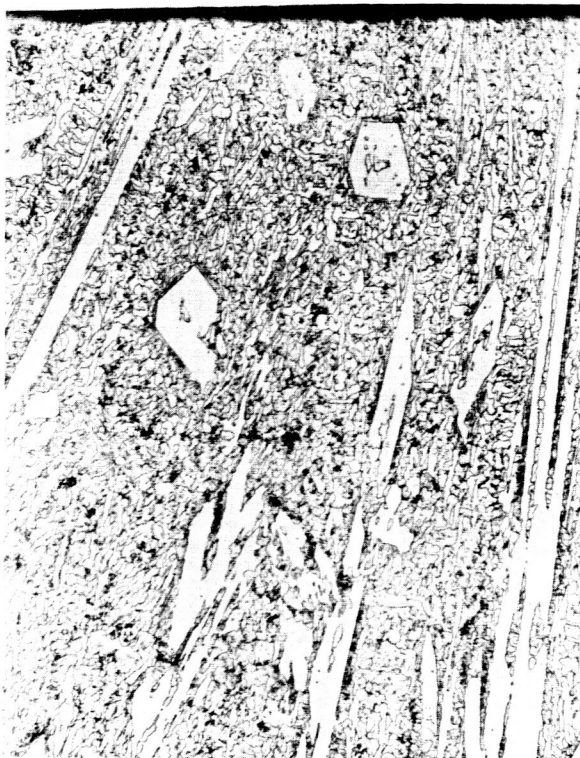
Etchant: 10%NaOH, Electrolytic

Mag: 2000X

Post-Test Liquid Zone (A050521)

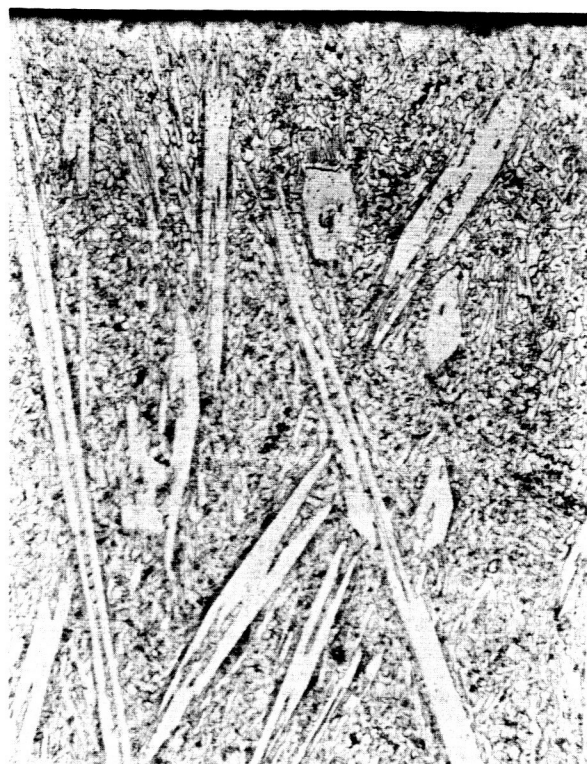
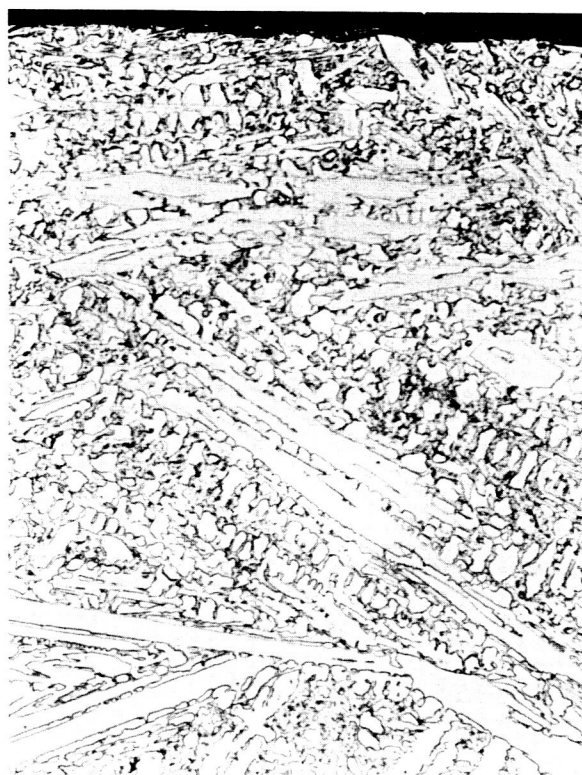
Figure 33. Microstructure of Star J (17%W-32%Cr-2.5%Ni-3%Fe-2.5%C-Bal Co) Alloy Before and After Exposure to Potassium Liquid and Vapor for 1000 Hours at 1600°F.

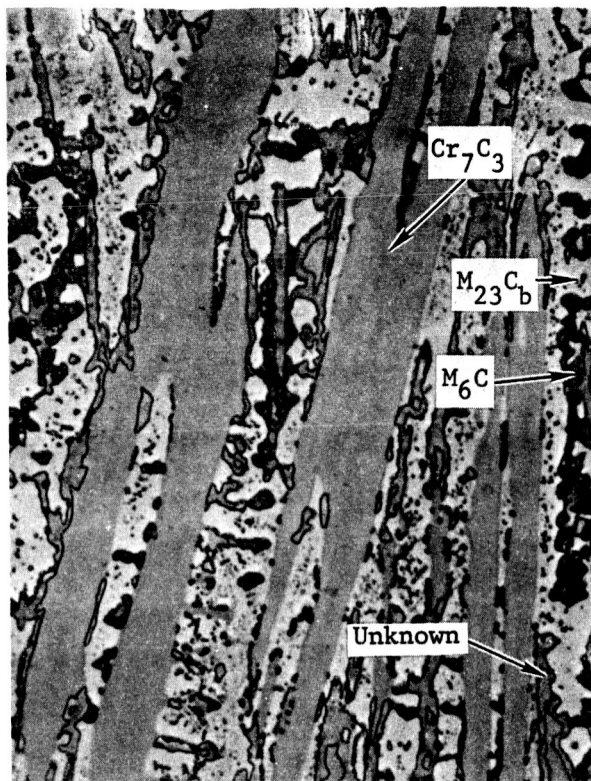
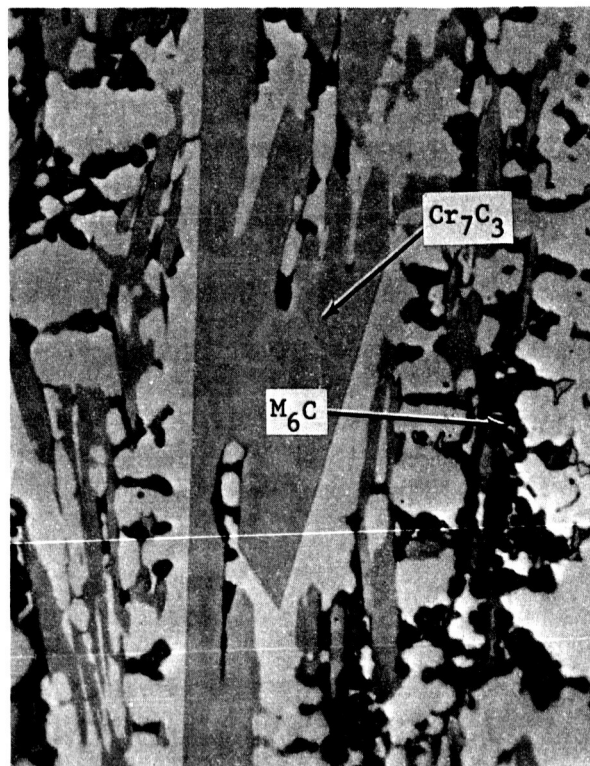
Figure 34. Microstructure of Star J (17%W-32%Cr-2.5%Ni-3%Fe-2.5%C-Bal Co) Alloy Before and After Exposure to Potassium Liquid for 1000 Hours at 1600°F.
Etchant: 2% Chromic Acid, Electrolytic + Grosbeck's Reagent
Mag: 1000X

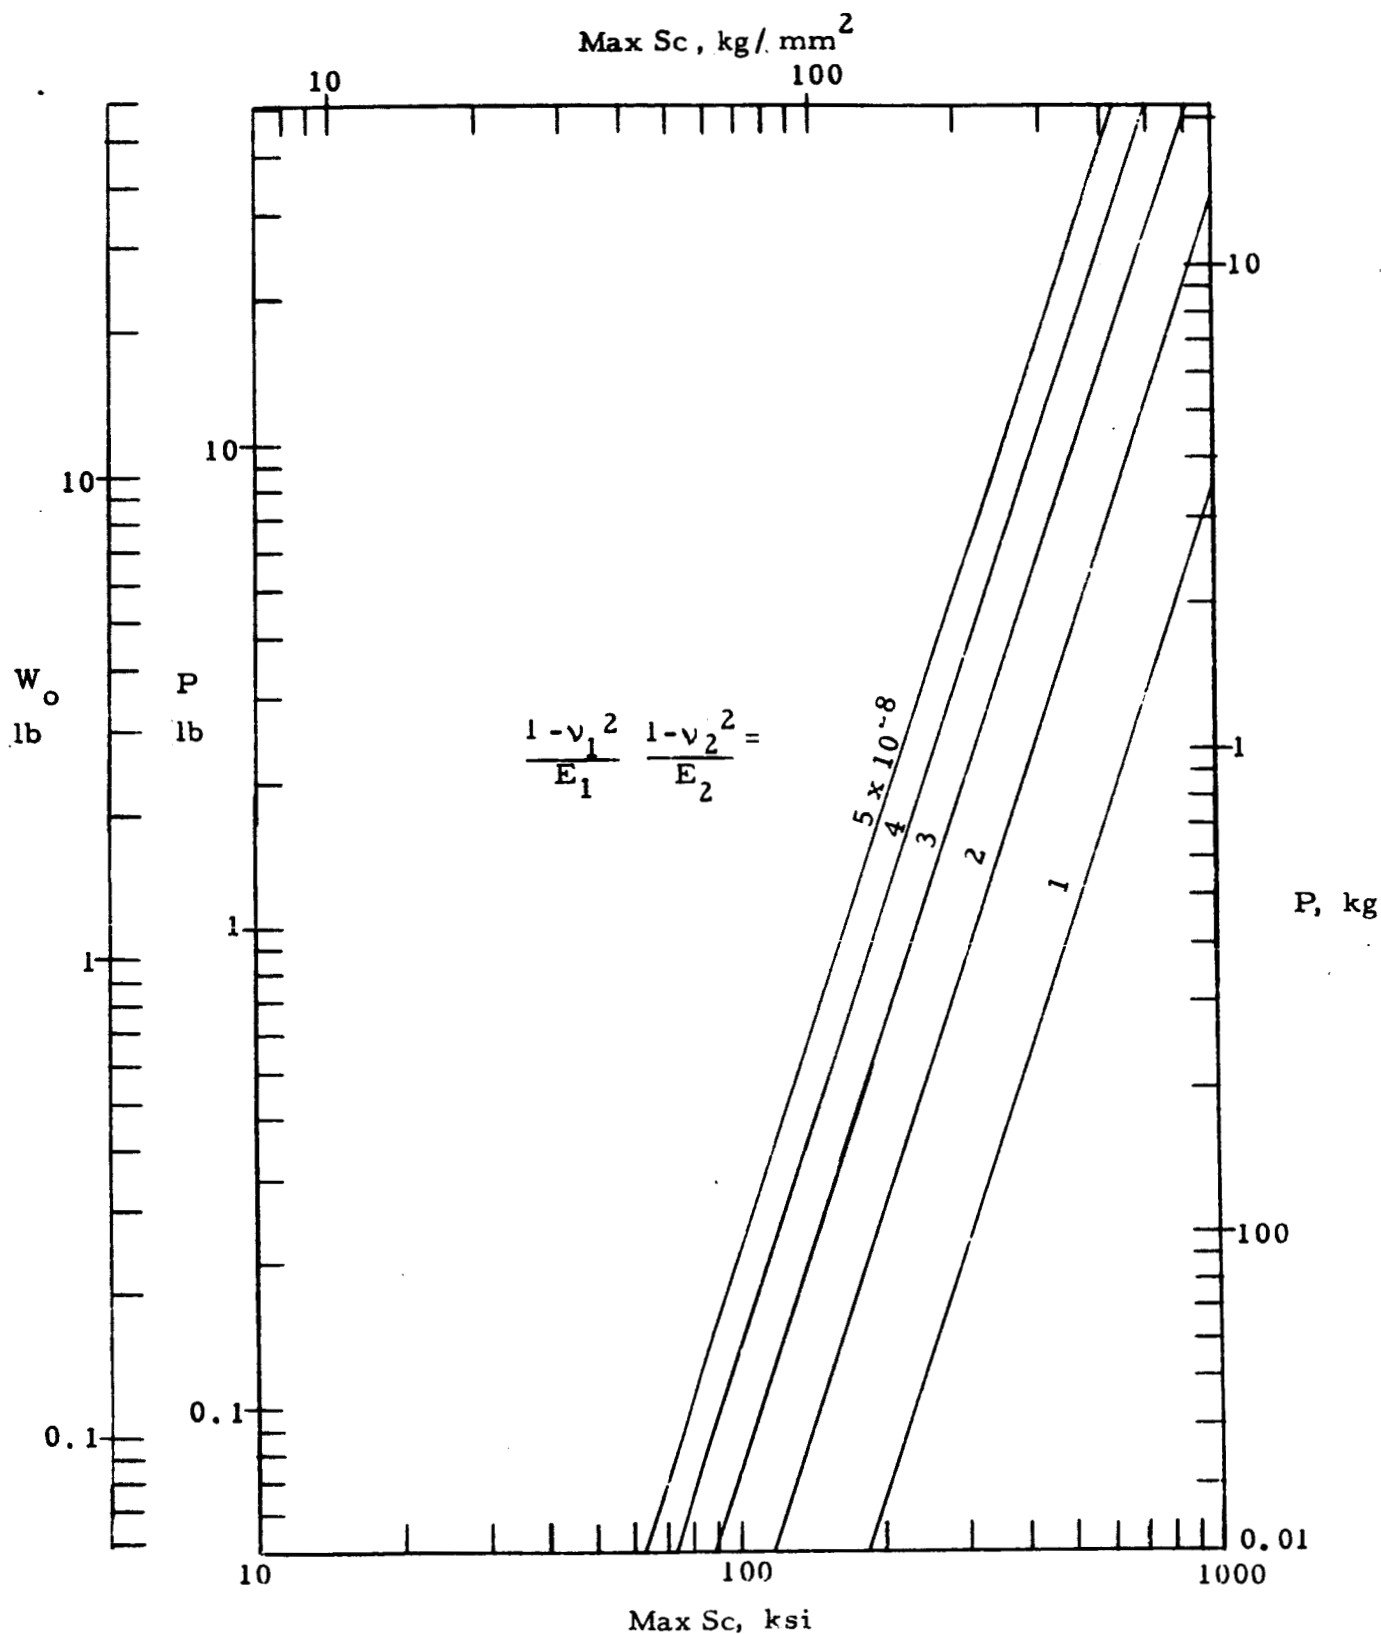
Figure 35. Curve for Calculation of Load to Produce Hertzian

Stress of (Max Sc) Between Sphere and Flat Surface;
